**Altered Watercourse Identification using GIS
A Pilot Project**

Final Report

Prepared by: Land Management Information Center (LMIC)

Prepared for: Minnesota Pollution Control Agency

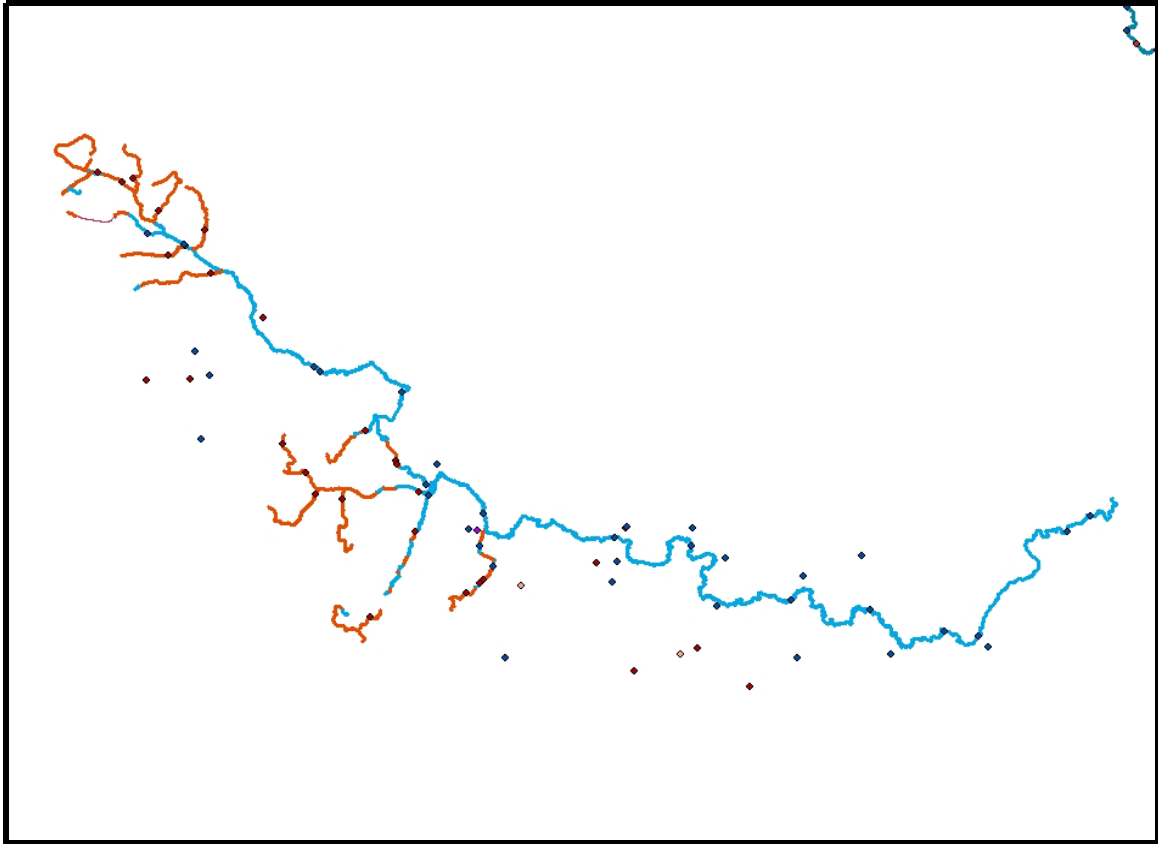
Results for North Fork Crow River – Subbasin 07010204

Subbasin	Name	NHDFlowline Total (km)	Altered streams completed (km)	% of Subbasin Completed	Hours to complete
07010204	N. Fork Crow River	2,576.365	497.619	19.3%	8

Subbasin	Altered Streams Completed (km)	Natural Streams (km - %)	Altered Streams (km - %)	Unassigned (km - %)
07010204	497.619	321.9 km – 65%	170.5 km – 34%	5.2 km – 1%

Subbasin	Altered Points/Altered Streams	Altered Points/Natural Streams	Natural Points/Natural Streams	Natural Points/Altered Streams
07010204	16	4	19	0

39 of the 89 Site Evaluation Points in the Subbasin were compared. 35 of the 39 MPCA Site Evaluation points agreed with the LMIC Altered/Natural Event designation.

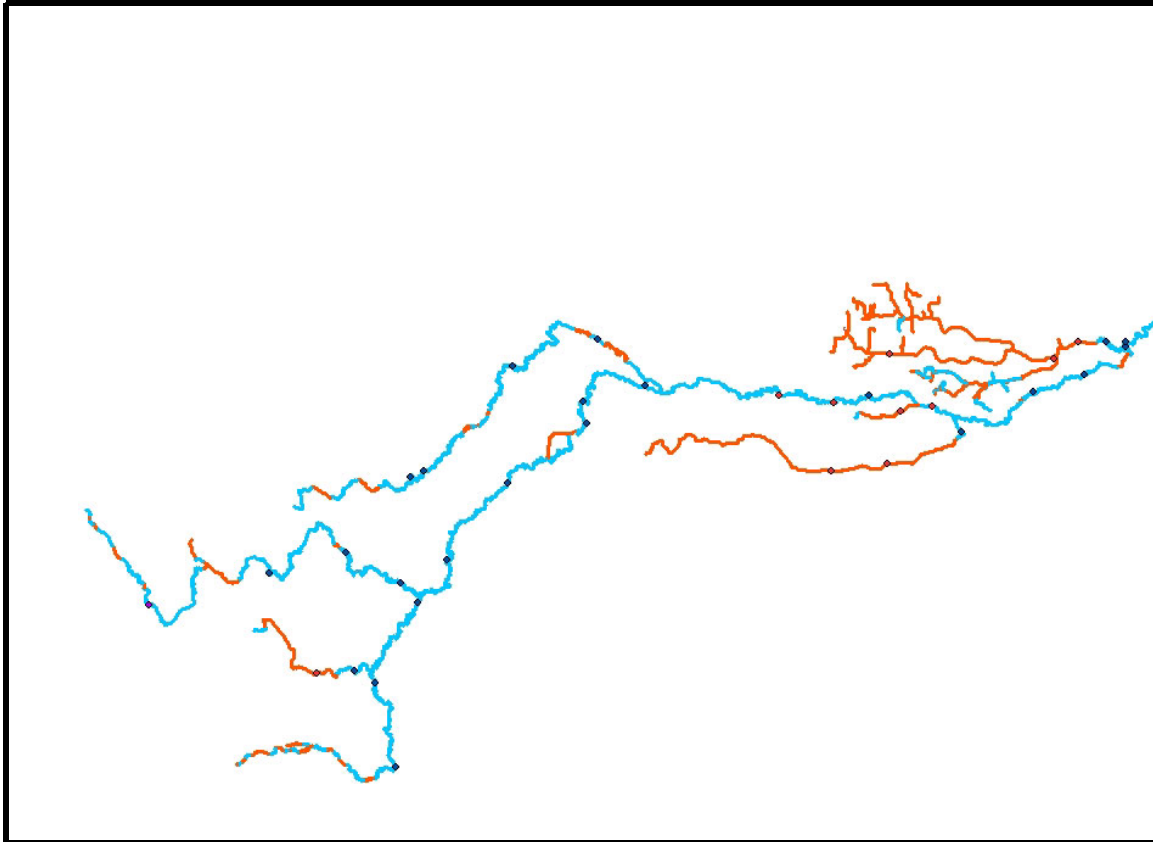
Results for Redwood River Subbasin – 07020006

Subbasin	Name	NHDFlowline Total (km)	Altered streams completed (km)	% of Subbasin Completed	Hours to complete
07020006	Redwood River	1,551.554	588.365	37.9%	8

Subbasin	Altered Streams Completed (km)	Natural Streams (km - %)	Altered Streams (km - %)	Unassigned (km - %)
07020006	588.4 km	377.4 – 64%	210.3 km – 36%	0.6 km - 0%

Subbasin	Altered Points/Altered Streams	Altered Points/Natural Streams	Natural Points/Natural Streams	Natural Points/Altered Streams
07020006	6	4	23	0

34 of the 74 Site Evaluation Points in the Subbasin were compared. 29 of 33 MPCA Site Evaluation points agreed with the LMIC Altered/Natural Event designation. One MPCA point was ambiguous.

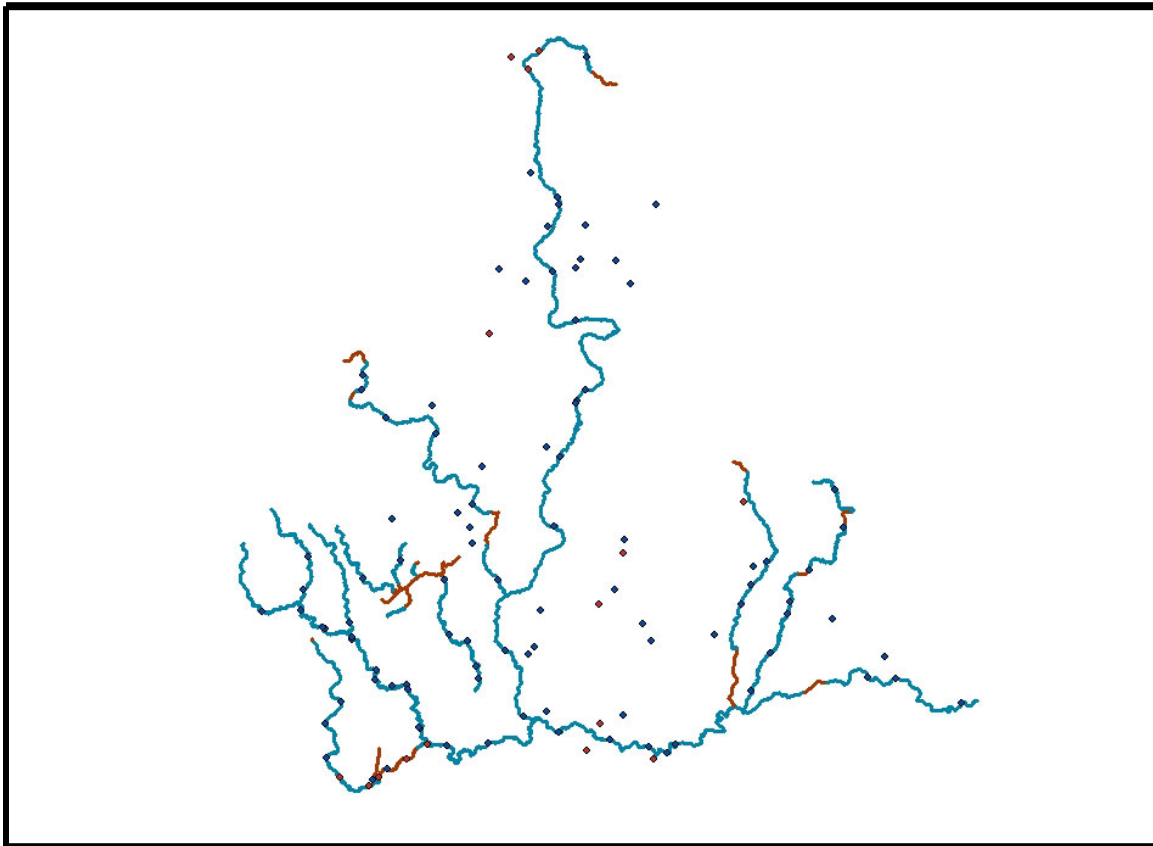
Results for Snake River Subbasin (St. Croix Basin) – 07030004

Subbasin	Name	NHDFlowline Total (km)	Altered streams completed (km)	% of Subbasin Completed	Hours to complete
07030004	Snake River	1,662.633	455.547	27.4%	11.5

Subbasin	Altered Streams Completed (km)	Natural Streams (km - %)	Altered Streams (km - %)	Unassigned (km - %)
07030004	455.547	407.0 km – 89%	48.5 km – 11%	0

Subbasin	Altered Points/Altered Streams	Altered Points/Natural Streams	Natural Points/Natural Streams	Natural Points/Altered Streams
07030004	2	5	63	2

72 of the 203 Site Evaluation Points in the Subbasin were compared. 65 of the 72 MPCA Site Evaluation points agreed with the LMIC Altered/Natural Event designation.

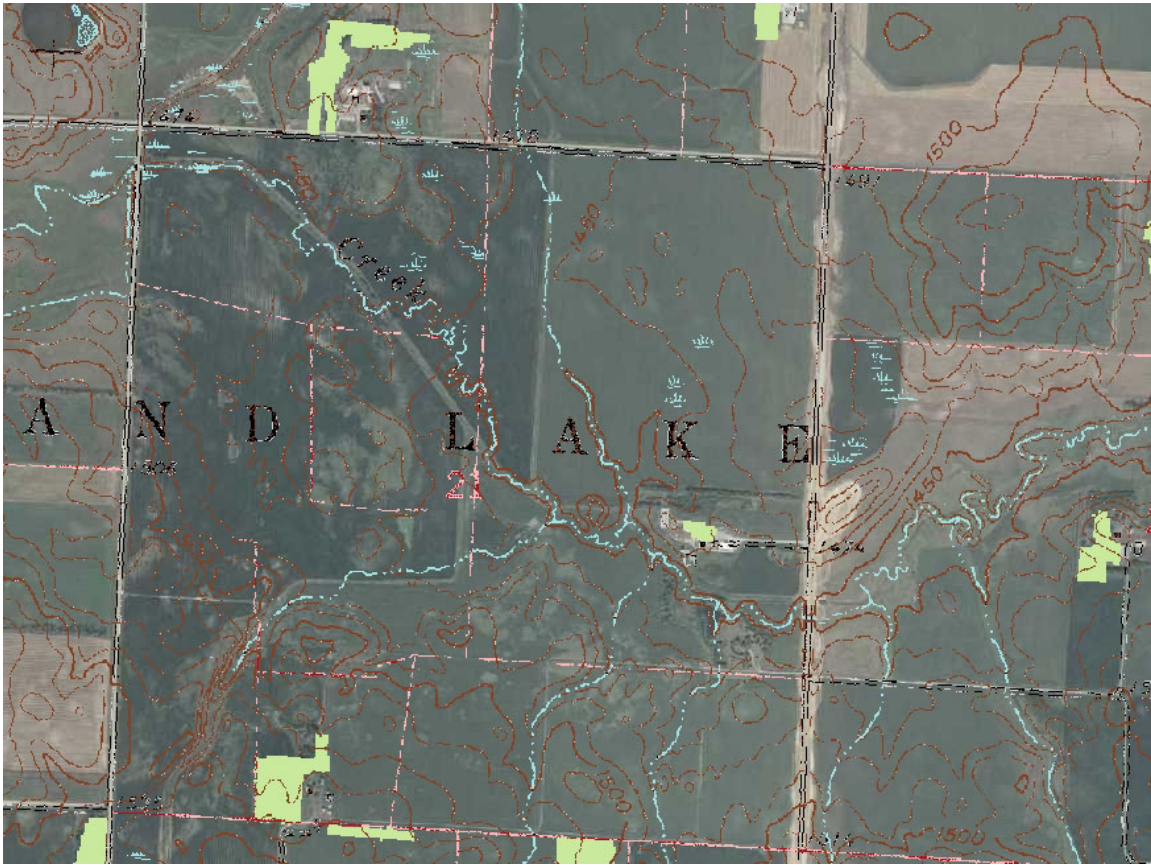
The first image shows the DRG of the quad map superimposed over FSA 2003 imagery. The quad map indicates a meandering stream segment that is no longer there.

LMIC did a qualitative comparison by looking at some of the areas where a stream segment identified on NHD as ‘Stream/River’ is identified as ‘Altered’ on the ‘Altered Event’ file. In a number of cases – and as was to be expected – the NHD stream feature followed the DRG, which indicated a meandering stream on the map, whereas the 2003 and 2006 aerial photography indicated that the stream segment had been ditched. The example below – a segment of Threemile Creek in the Redwood River watershed - is typical.

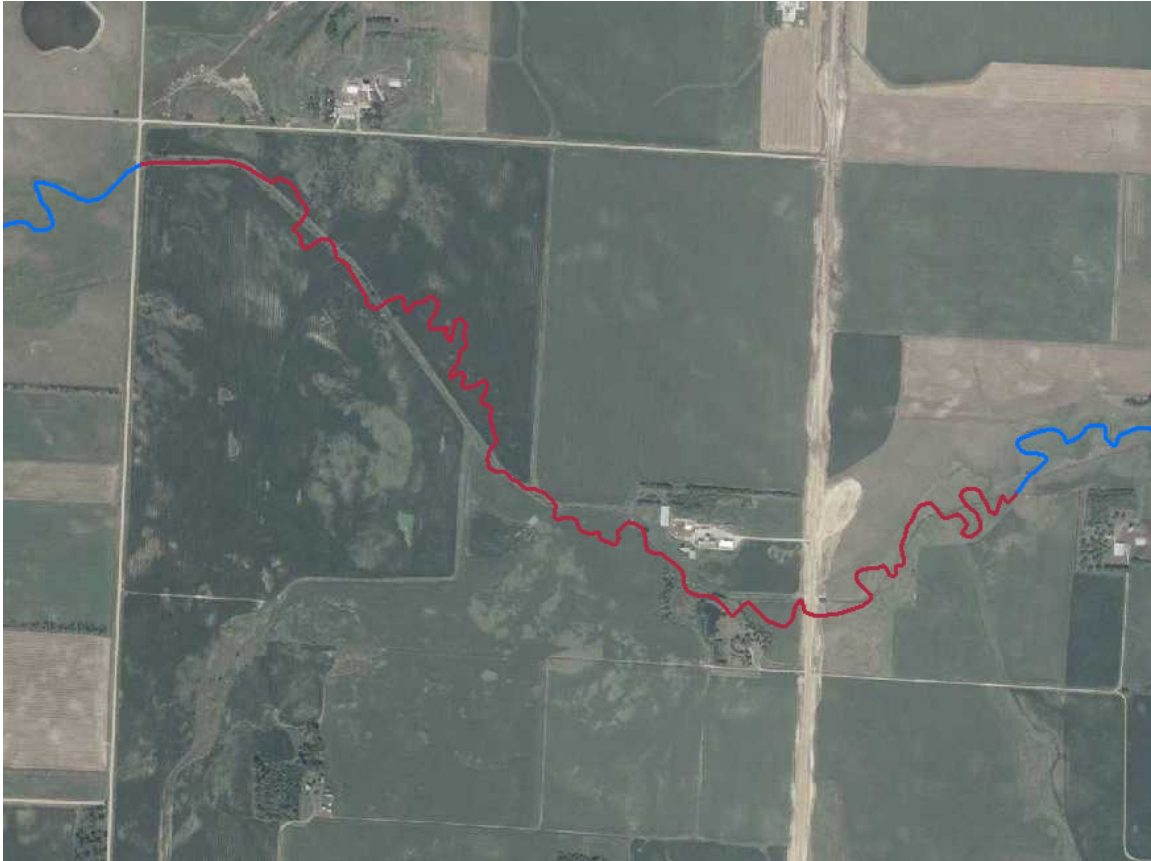
The second image shows the altered events linework which traces the NHD linework. However, the event type code indicates that the segment in red is altered, not natural. The Comments field says 'Replace stream with ditch'. Since the stream segment modification appears to be permanent, this change should be made on the NHD – replacing the linework to match the current ditch and changing the feature type code.

The North Fork Crow River and Snake River Subbasins had around 4% of the linework needing a change of coding and updating of linework on the NHD. The second graphic under section 3.4.2.4 is an excellent example of the type of update often needed.

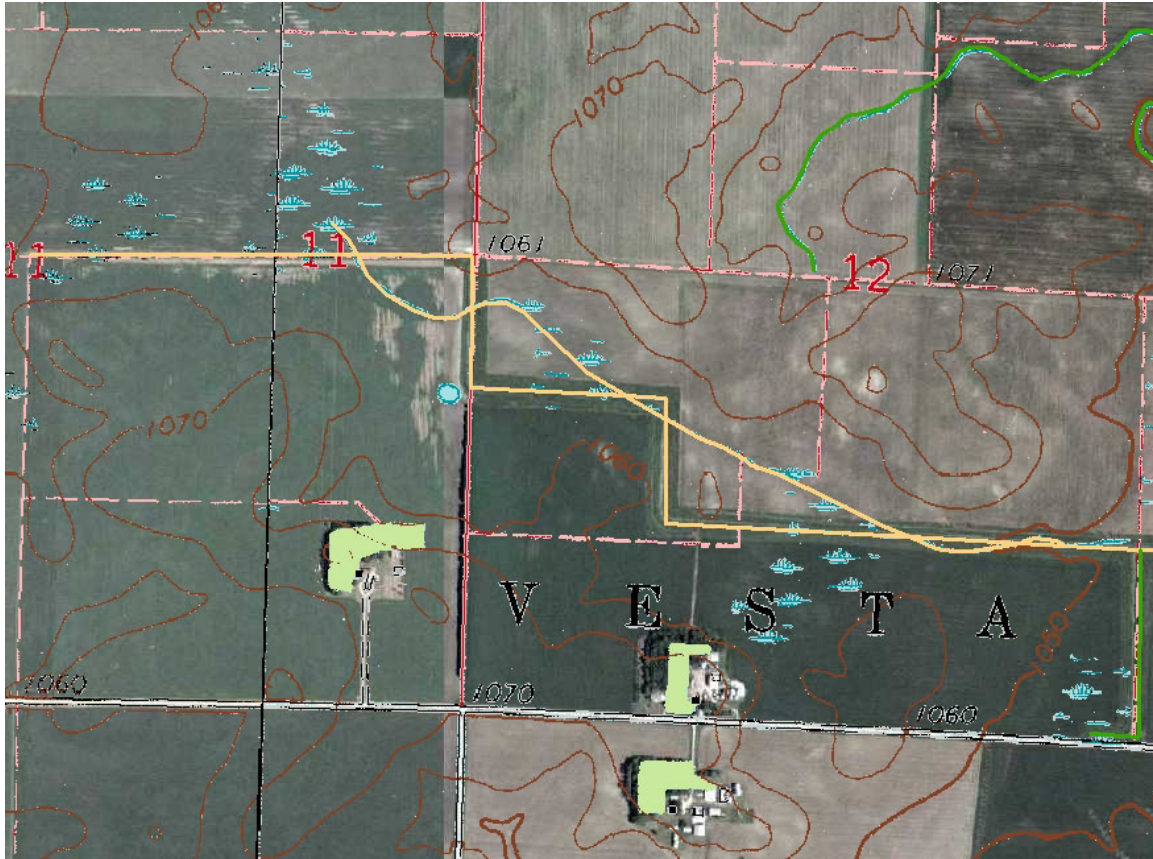
The Redwood River subbasin had a high percentage of NHD lines needing update – almost 10%. The graphic below shows a common situation in the subbasin and may indicate why the 'NeedsUpdate' percentage is so high. The original DRG shows a meandering stream; the NHD shows both the meandering stream and a ditch feature that gradually replaced the stream; current imagery indicates that the formerly meandering stream is now totally erased from the landscape. Since both the old stream on the NHD and the new ditch on the NHD are coded as 'NeedsUpdate' on the Altered Streams file, (with the comment 'Overlying Stream should be removed from NHD. It no longer exists per photos'), there may be some over-reporting – but it does indicate that more changes need to be made to the NHD.
