Altered Watercourse Determination Methodology

Final Revision (8)

**Minnesota Geospatial Information Office (MnGeo)
For
Minnesota Pollution Control Agency (MPCA)
June, 2013**

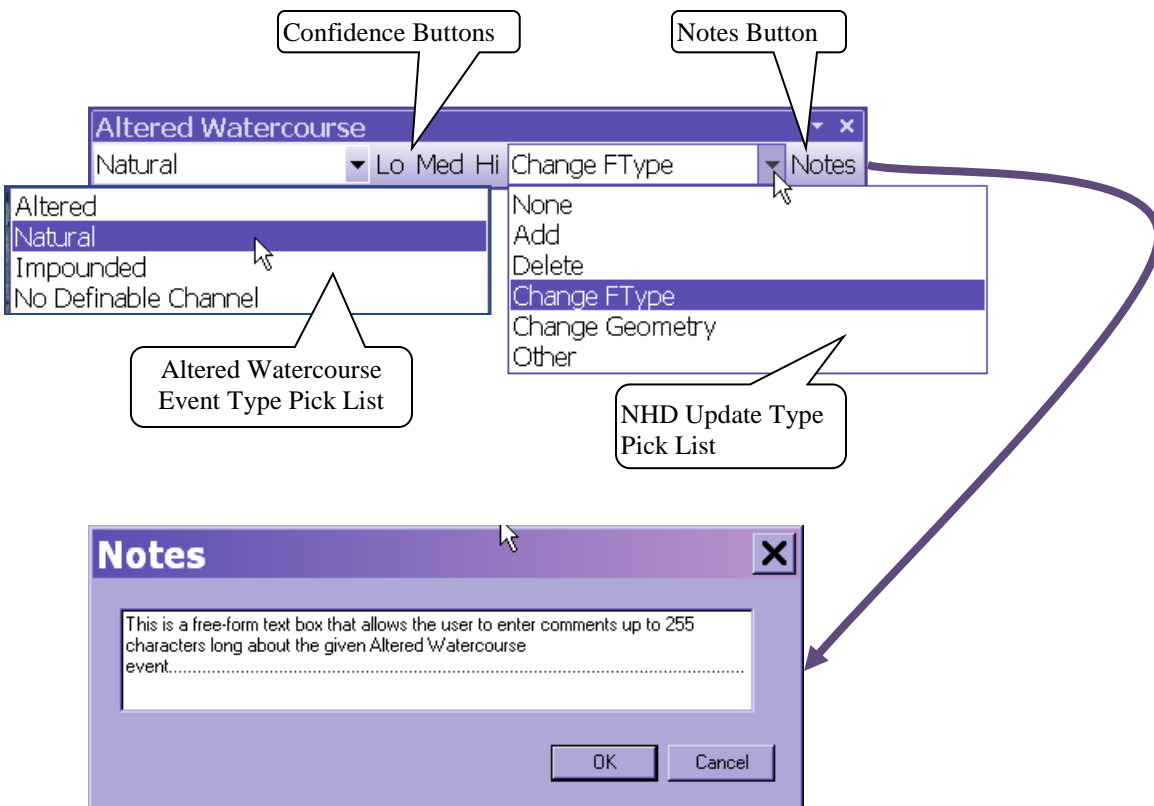
18. The following figure shows the Altered Watercourse toolbar and its various tools:

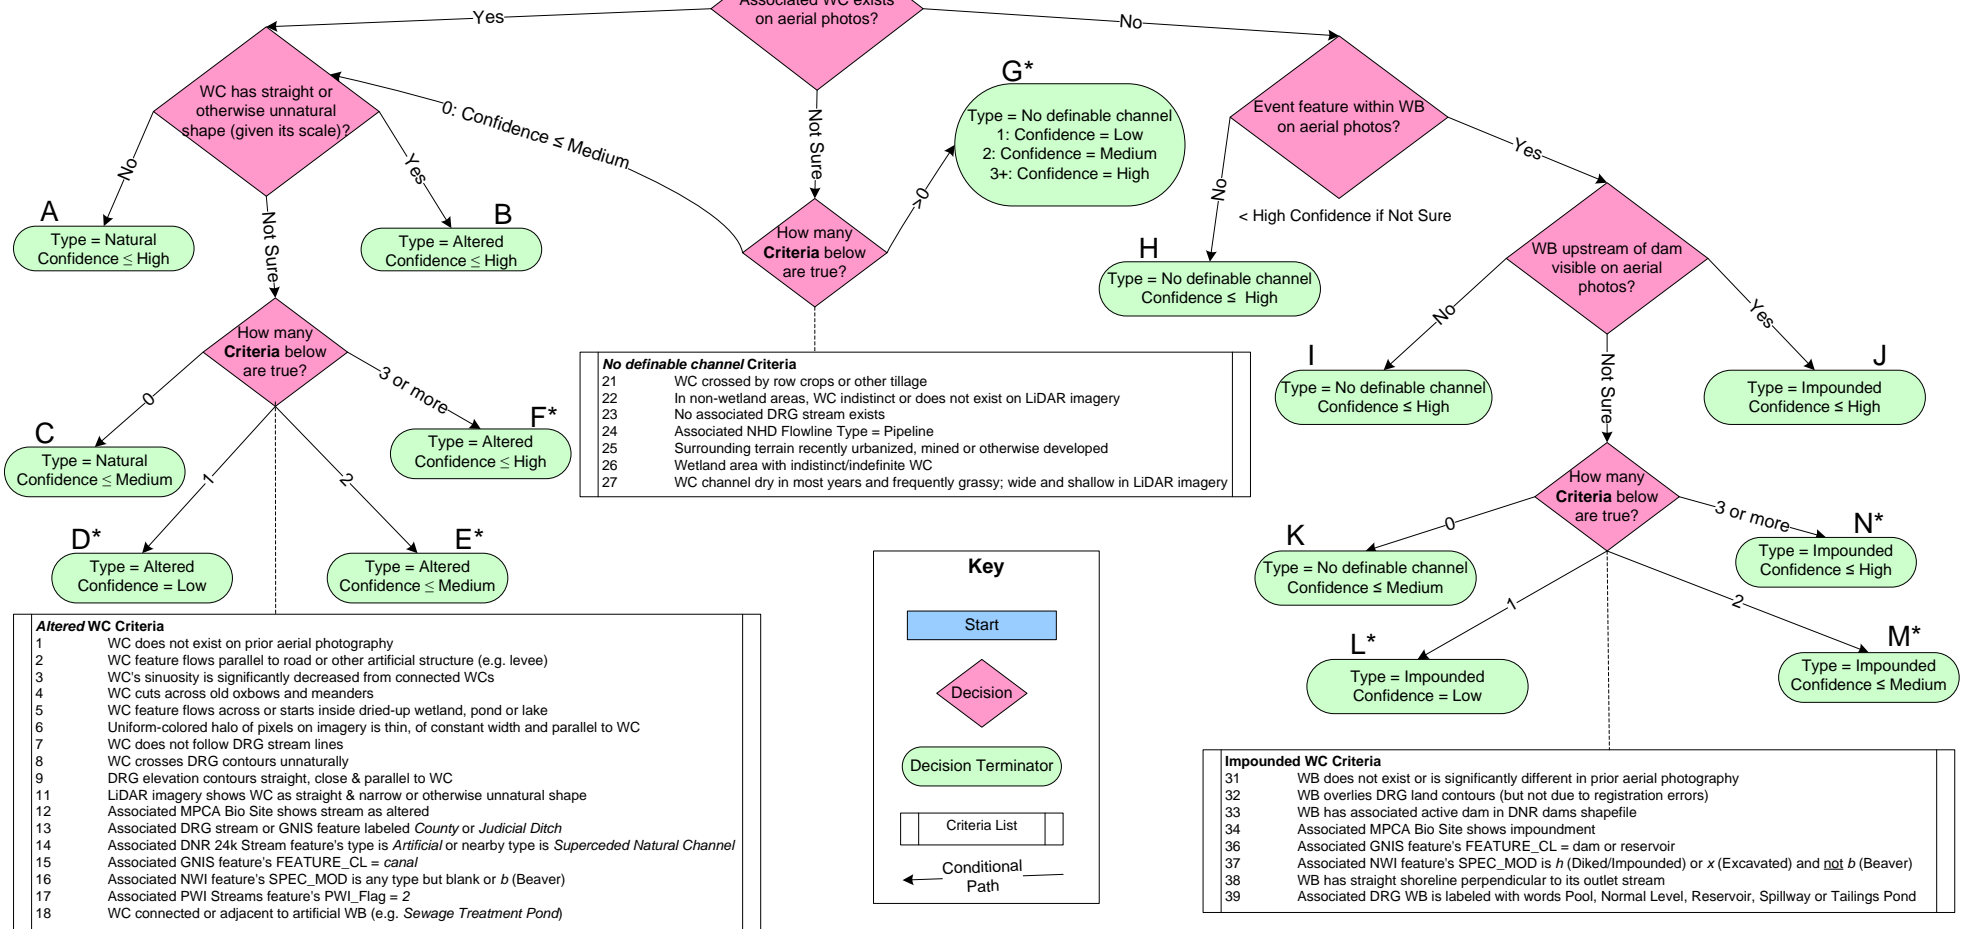
NOTE: The WC (watercourse) and WB (waterbody) represent the stream segment and body of water, respectively, as seen on the aerial photography. The letter above each decision terminator can be used to track the criteria used to make an event type and confidence determination. Those with * should include the numbers of the Altered, No definable channel or Impounded criteria used (e.g. E(2,13)).

In addition, certain decision terminators require additional criteria that are found in the tables Altered Criteria and Impounded Criteria below. Each of these criteria is numbered uniquely and its value is recorded by the analyst into one of three criteria number fields (*CritNum1*, *CritNum2*, and *CritNum3*). The number of these criteria required is determined by the chosen decision terminator. The analyst should enter some value into the criteria fields even if uncertain but use the *Confidence* and *Notes* field to indicate their level of (un)certainty.

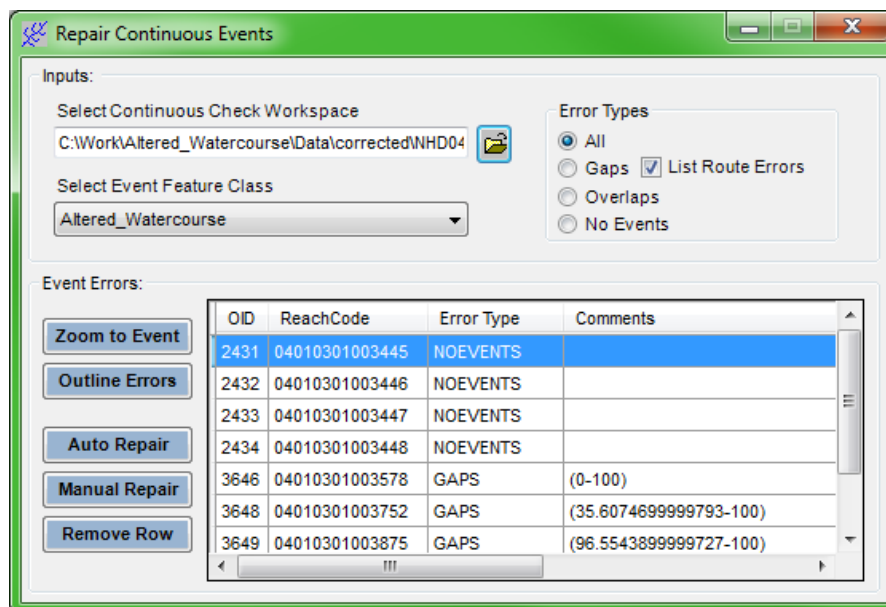
4. Click Edit Tools > Repair Continuous Events tool

on the HEM toolbar. The following dialog will appear:

5. Enter the error report geodatabase created in step 1 into the **Select Continuous Check Workspace** control. Pick *Altered_Watercourse* under **Select Event Feature Class** if necessary.

6. Select a record in this dialog.
7. Click the **Zoom to Event** and **Outline Errors** buttons to visualize the error on the map.
8. The Error Types and how to fix them are given below. (All buttons described pertain to the **Repair Continuous Events** dialog unless otherwise noted.)

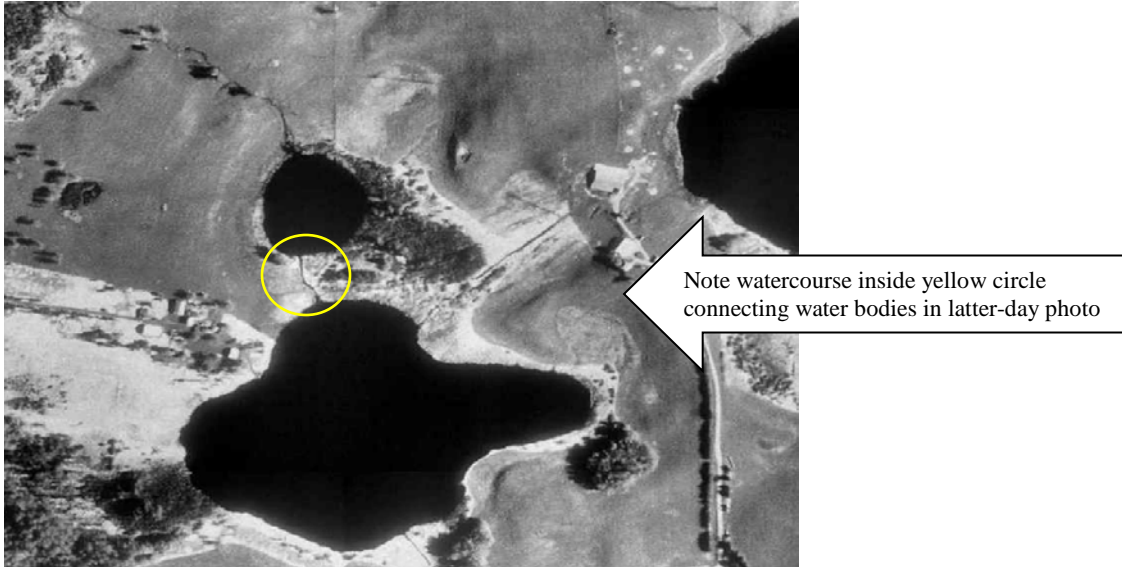
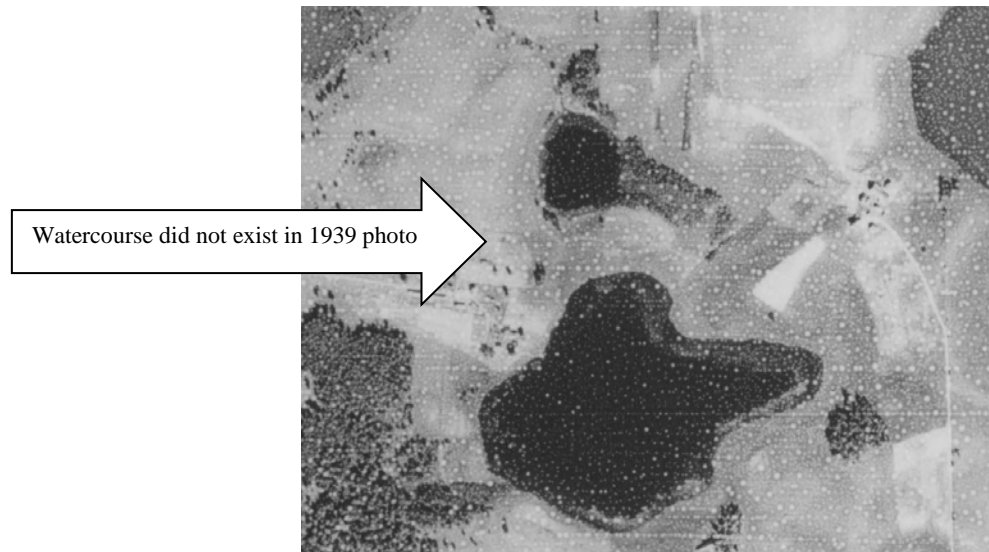
1. Watercourse does not exist on prior aerial photography

Unless there has been some kind of catastrophic event (e.g. earthquake, landslide) nature usually takes thousands of years to create a watercourse. Those created within a few decades are most likely artificial.

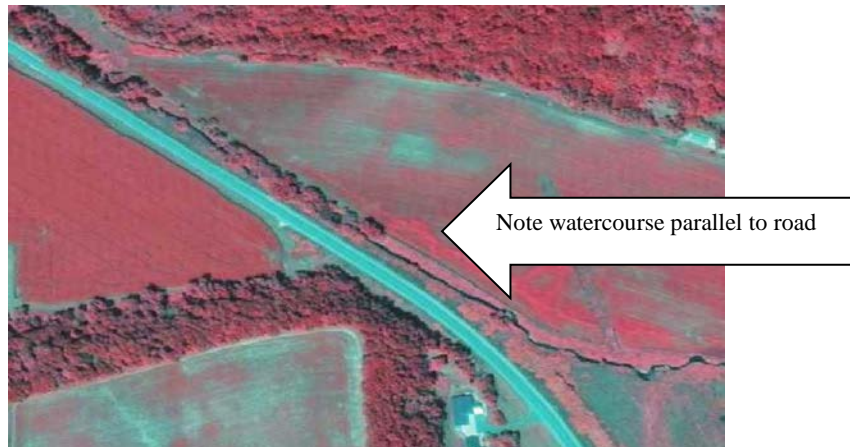
2. Watercourse feature flows parallel to road or other artificial structure (e.g. levee)

This indicates that the stream was modified to permit construction of artificial structure.

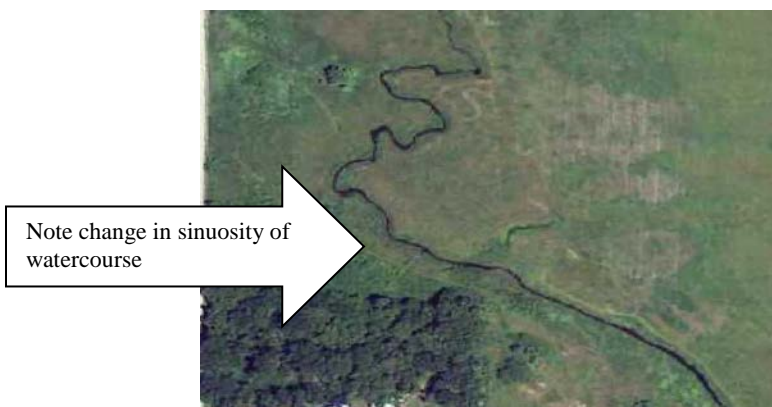
3. Watercourse's sinuosity is significantly decreased from connected watercourses

Because there are no straight lines in nature, altered streams are rarely as sinuous (i.e. have natural appearing curves) as natural streams.

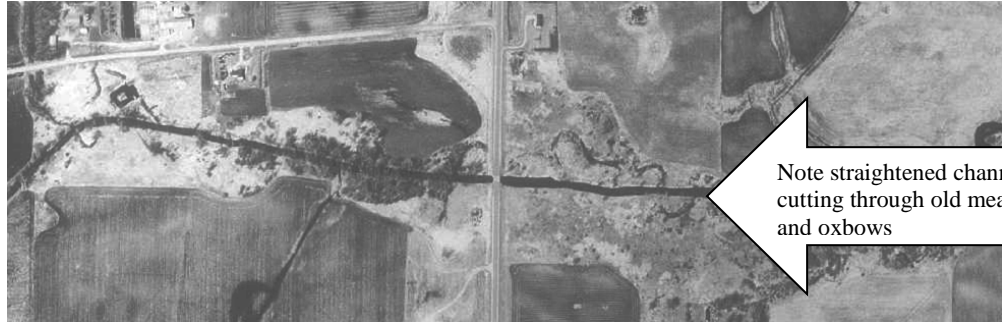
4. Watercourse cuts across old oxbows and meanders

An altered portion of a natural stream often cuts directly across the former meanders and oxbows of the original channel in an unnatural (i.e. straightened and direct) way.

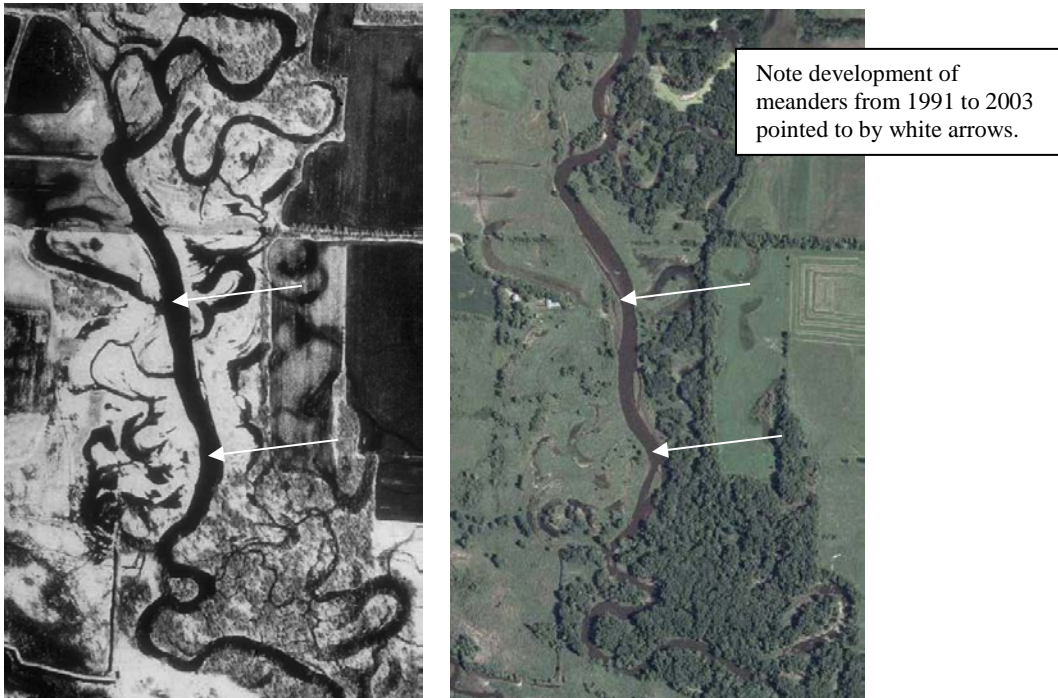
But, be careful channel is not a natural cut-off of a meander.

These will likely be shorter and more natural appearing than an artificial channel and, since they are by definition not dredged, may show development of their own meanders over time in the photos.

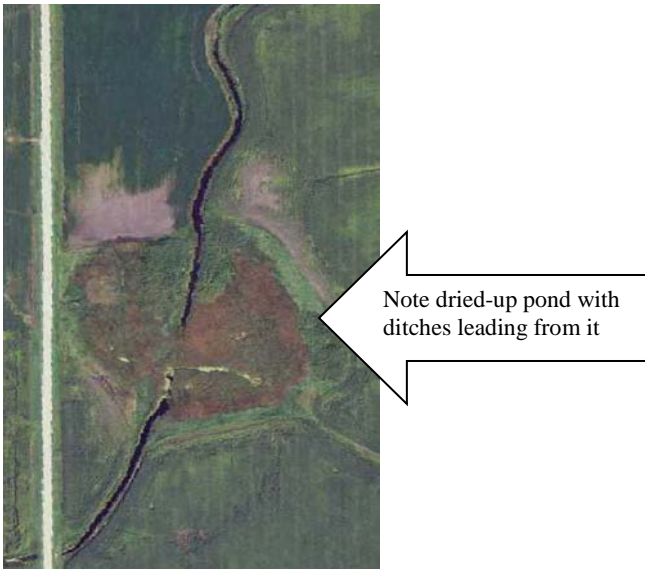
5. Watercourse feature flows across or starts inside dried-up wetland, pond, or lake
Ditches and altered streams are often used to drain old wetlands or water bodies.

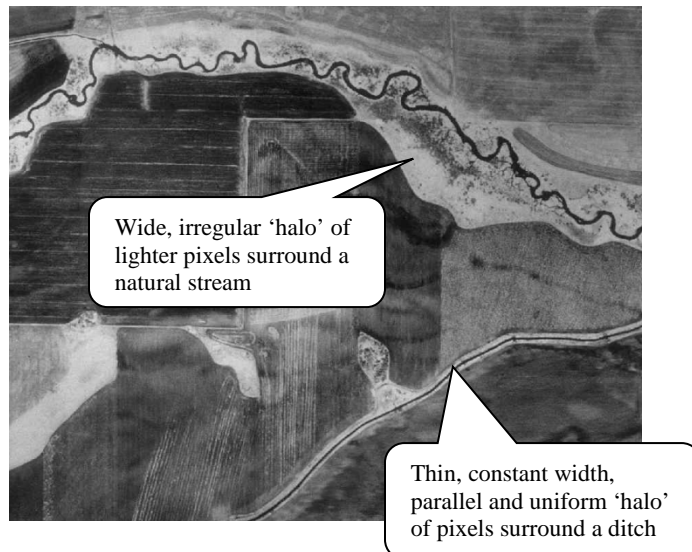
6. Uniform-colored halo of pixels on imagery is thin, of constant width and parallel to watercourse

The photographic imagery sometimes displays a watercourse with a 'halo' of uniform-colored pixels around the channel of dark-colored ones. The relative shape and width of these halos may be used to help determine if the watercourse is natural or altered. Halos that are thin, parallel to and the same shape as the watercourse itself are probably around an altered stream. If a natural watercourse has such a halo, it tends to be wider, less distinct in color from adjacent areas and more irregular in shape.

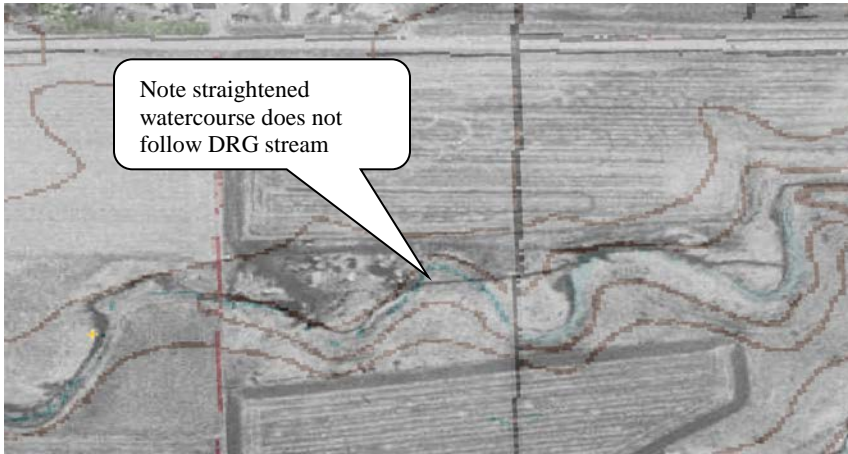
7. Watercourse does not follow DRG stream lines

Streams that have been altered since the DRG was created will often not follow the original DRG stream lines.

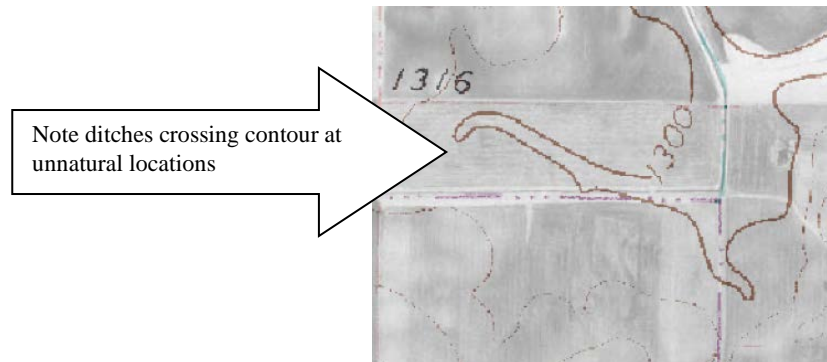
8. Watercourse crosses DRG contours unnaturally

Altered streams (especially those newer than the DRG) may cut across elevation contours at unnatural places or even appear to go uphill. Natural streams tend to cross at the V-shaped notches of contours and, of course, travel only downhill.

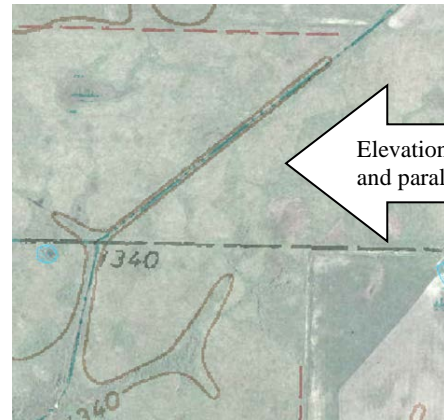
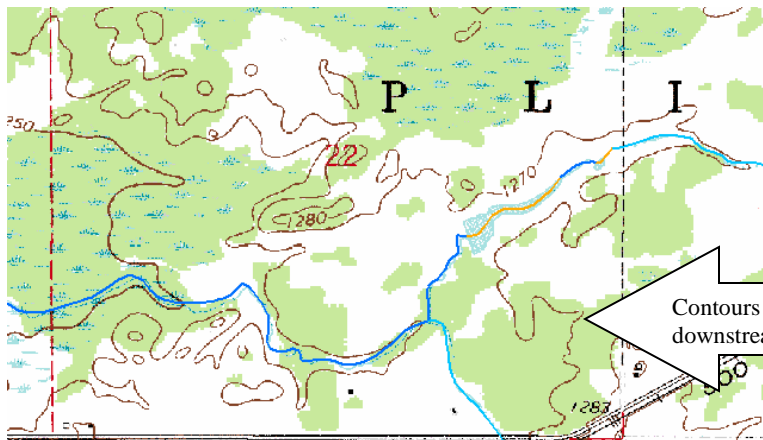
9. DRG elevation contours straight, close & parallel to watercourse

Many ditch/canals have close-in, straight elevation contours on the DRG that stay with them much of their length.

Contours that cross natural streams tend to move farther apart and become more irregular in shape as they go downstream.

Contours get wider and more irregular downstream after crossing natural streams

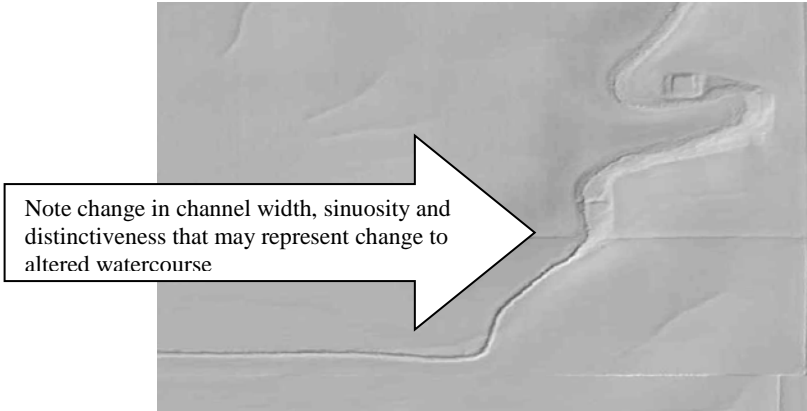
Because of the precise nature of LiDAR hillshade data it can sometimes help differentiate an altered from a natural stream by revealing unnatural characteristics not clearly visible in the aerial photography.

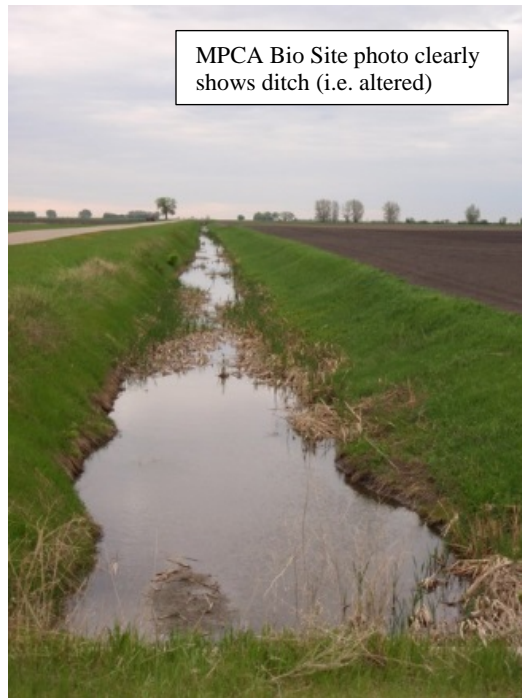
12. Associated MPCA Bio Site shows stream as altered

These lateral photos taken at ground level may give some clues as to whether a stream has been altered or not.

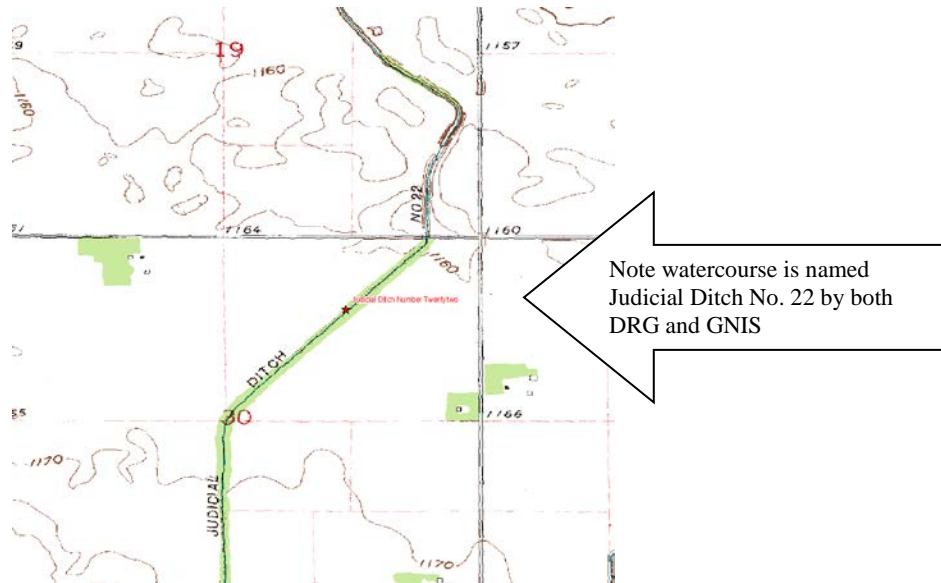
13. Associated DRG stream or GNIS feature labeled *County* or *Judicial Ditch*

The ditch labels in DRG or GNIS data are but one more clue that a given watercourse is altered.

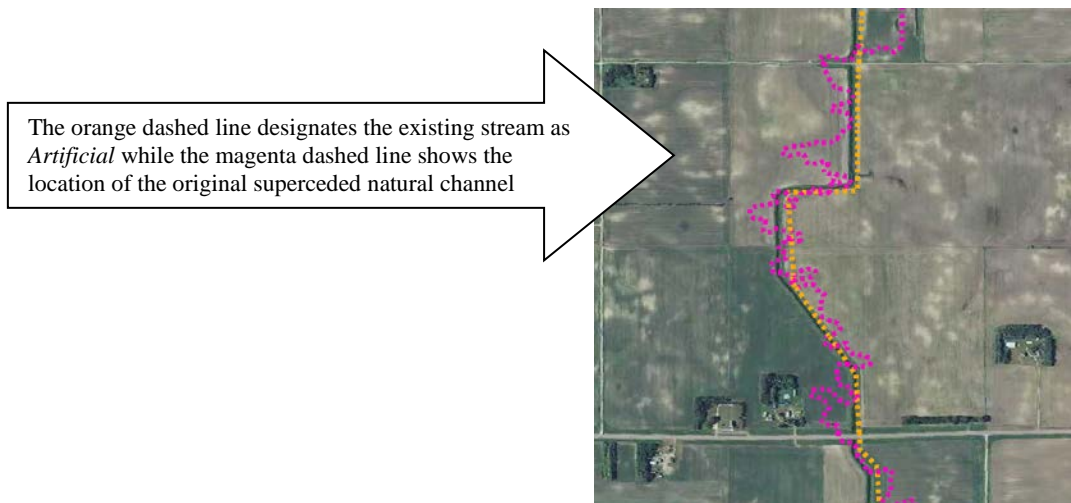
14. Associated DNR 24k Stream feature's type is *Artificial* or nearby type is *Superceded Natural Channel*

Although the DNR's definition of Artificial is not equivalent to Altered for this project, it may nonetheless indicate a stream has been altered. Also, a Superceded Natural Channel is a natural stream that has been replaced with an overlying or nearby artificial channel that may be Altered.

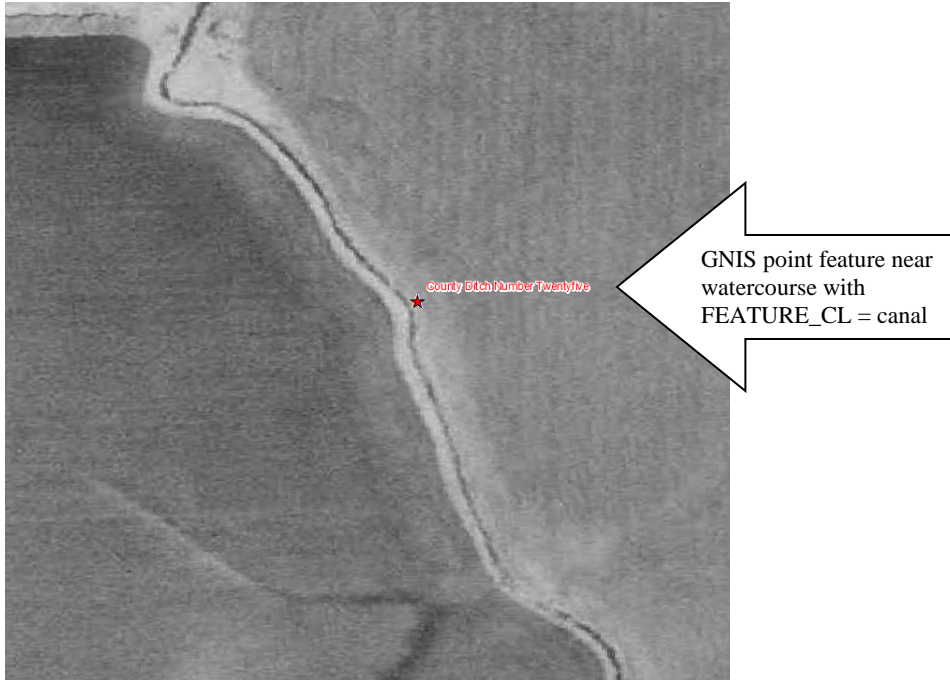
15. Associated GNIS feature's FEATURE_CL = canal

The Geographic Names Information System (GNIS) of the USGS includes hydrographic points of different classes (i.e. FEATURE_CL). The one named canal indicates an artificial channel.

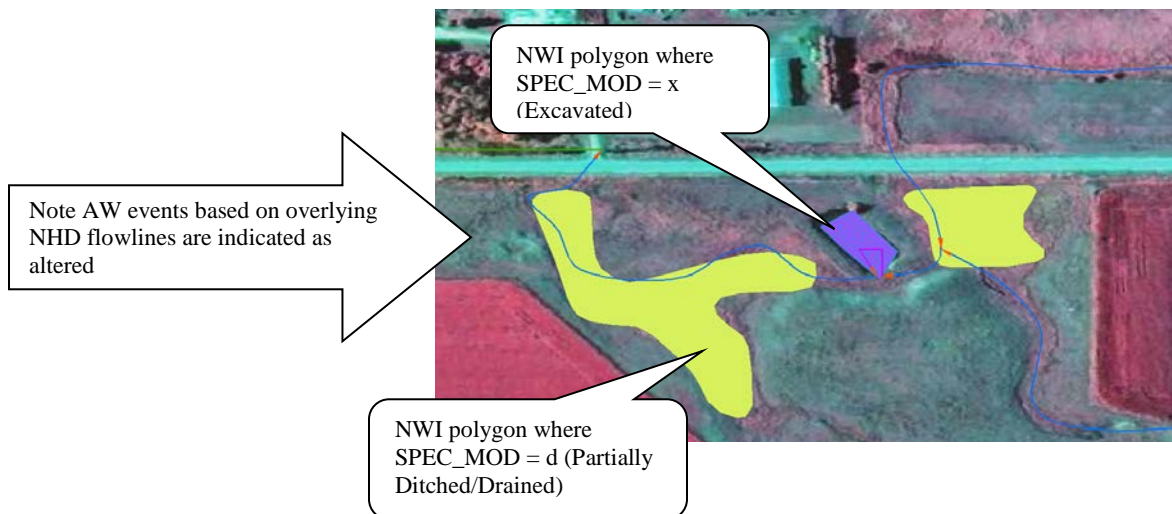
16. Associated NWI feature's SPEC_MOD is any type but blank or b (Beaver)

The National Wetlands Inventory (NWI) polygons may have values in their Special Modifier (SPEC_MOD) fields that indicate an overlying or nearby stream has been altered. These are: d = Partially Drained/Ditched, f = Farmed, h = Diked/Impounded, r = Artificial Substrate, s = Spoil and x = Excavated. Where SPEC_MOD = b means Beaver influenced area and therefore does not indicate an altered watercourse.

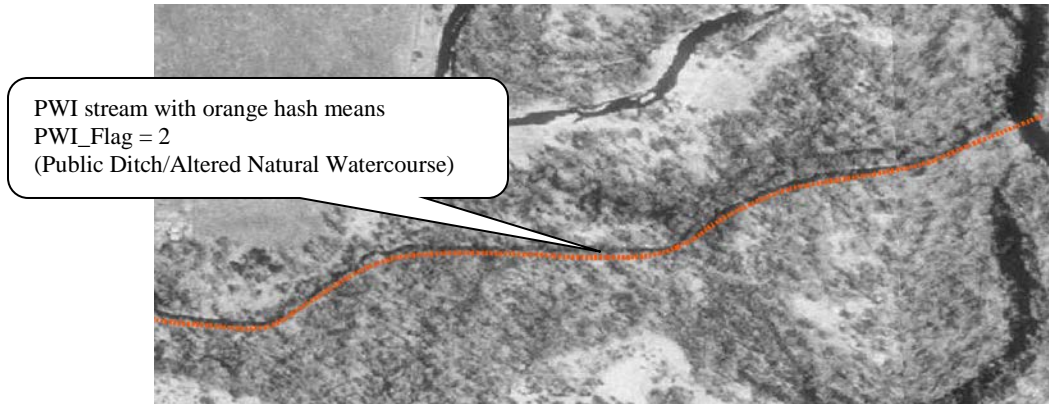
17. Associated PWI Streams feature's PWI_Flag = 2

Public Waters Inventory (PWI) streams from the DNR may have PWI_Flag = 2 which designates the stream as *Public Ditch/Altered Natural Watercourse*. Although not equivalent to Altered in this project's context it nonetheless may indicate the stream is Altered.

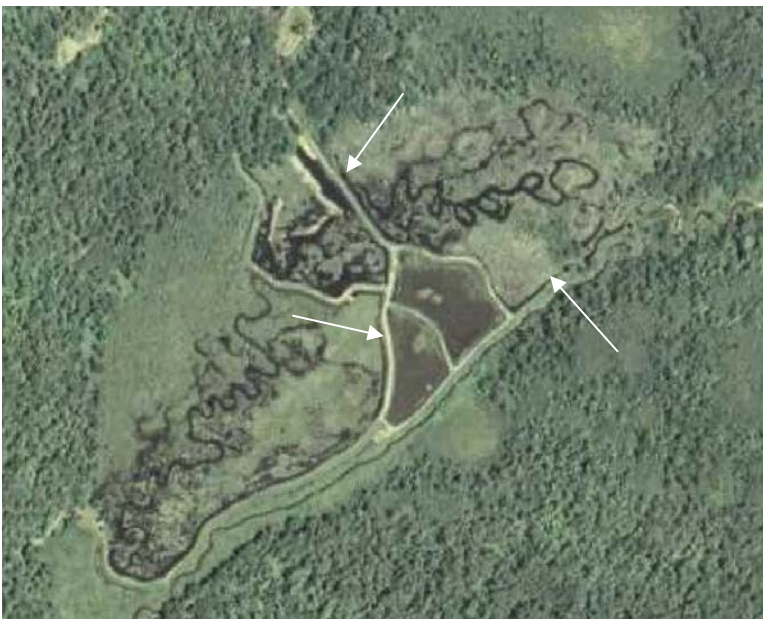
18. Watercourse connected or adjacent to artificial Waterbody (e.g. Sewage Treatment Pond)

Watercourses flowing into and out of man-made reservoirs are usually altered (see watercourse pointed to by white arrows in photo). Reservoirs may be found using the FType of the NHDWaterbody layer, labeled as such on the DRG or seen on the imagery as a darker polygon with a regular (e.g. rectangle or circle) or otherwise non-natural shape.

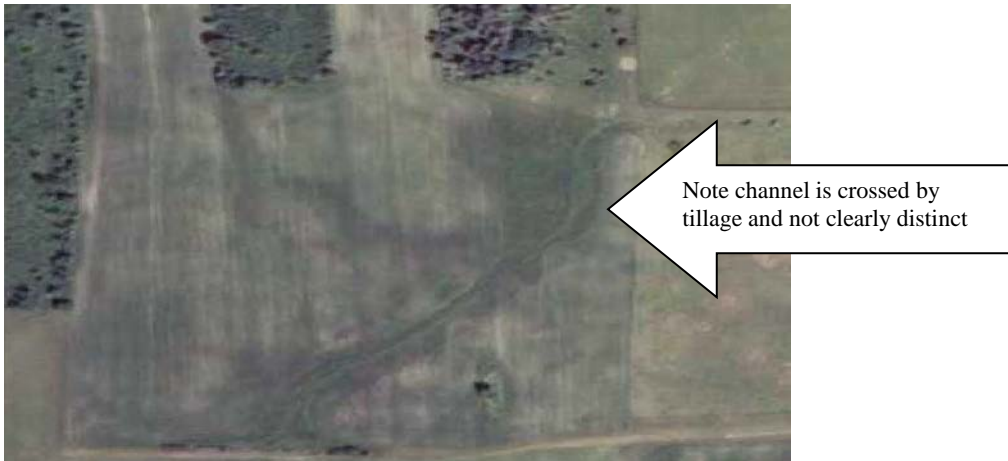
A channel that has been planted over or tilled is likely too small or indistinct.

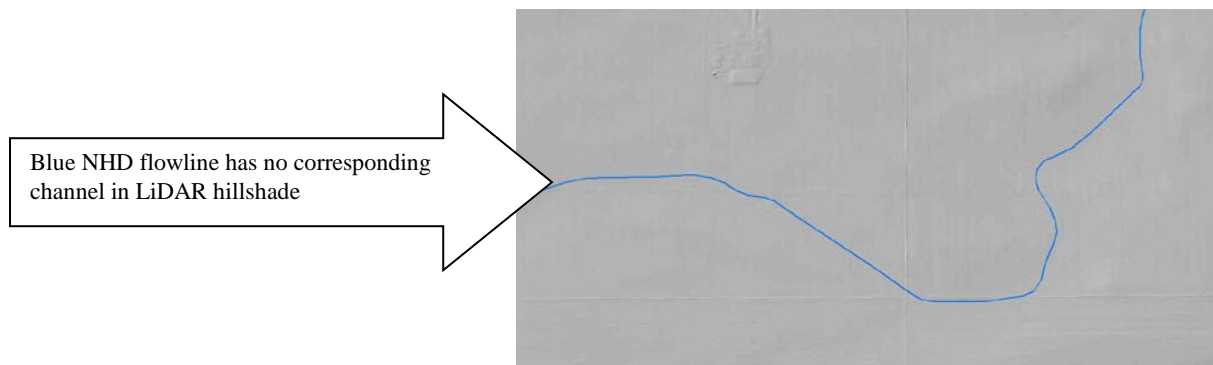
22. In non-wetland areas, watercourse indistinct or does not exist on LiDAR imagery

Except in wetland areas, LiDAR is very good at penetrating vegetative cover (i.e. tree canopies) and showing natural stream and ditch channels even when they are not visible in aerial photography. Therefore, if a watercourse channel (in a non-wetland area) is not clearly visible on LiDAR hillshade imagery then it likely doesn't exist or is too small for MPCA purposes.

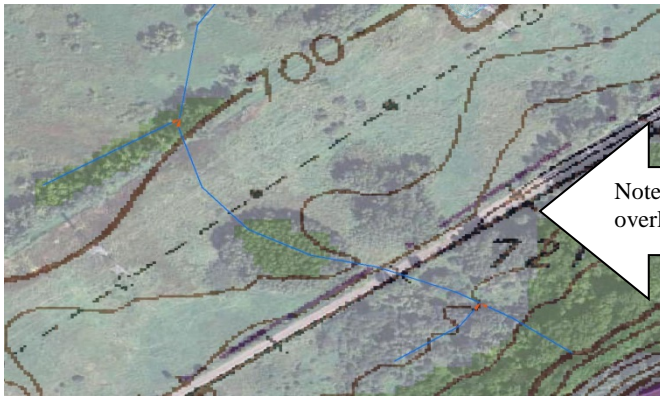
An NHD flowline (on which AW events are built) that does not have an associated Digital Raster Graphic (DRG) stream line is either: a new, likely Altered watercourse or a mistake. If the aerial imagery (including LiDAR hillshade) clearly shows a channel then criteria #7 is satisfied (Watercourse does not follow DRG stream lines) and the watercourse will be considered Altered. However, if the aerial imagery does not clearly show a channel then this criteria (#23) is satisfied and the watercourse is considered *No definable channel*.

Note thin blue NHD flowline overlying DRG & aerial photo

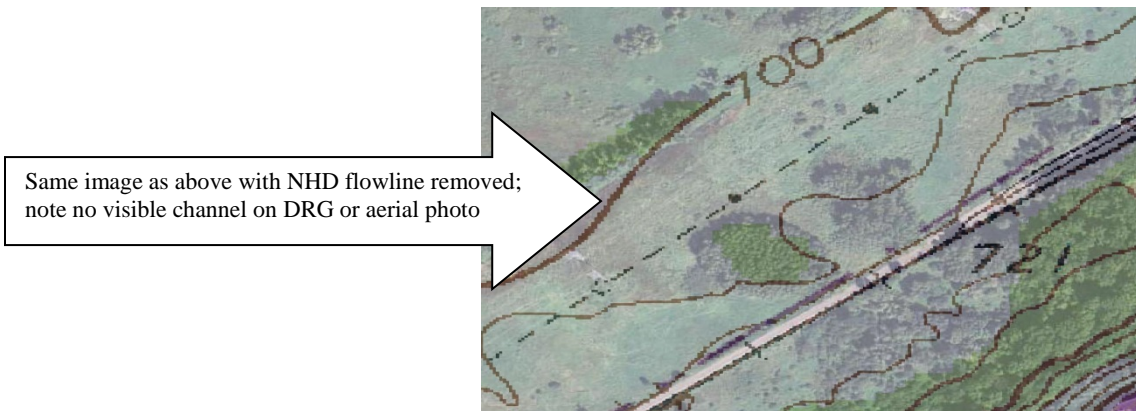
Same image as above with NHD flowline removed; note no visible channel on DRG or aerial photo

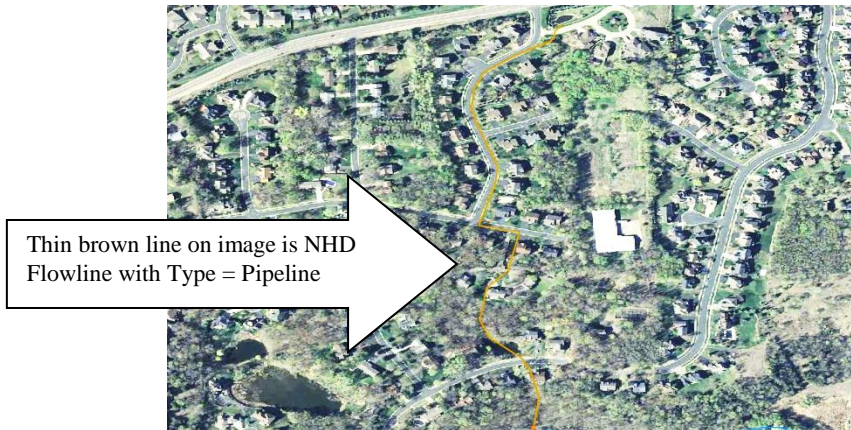
24. Associated NHD Flowline Type = Pipeline

NHD Flowlines designated as Pipelines are generally water supply conveyance or storm water features that are underground and therefore not visible.

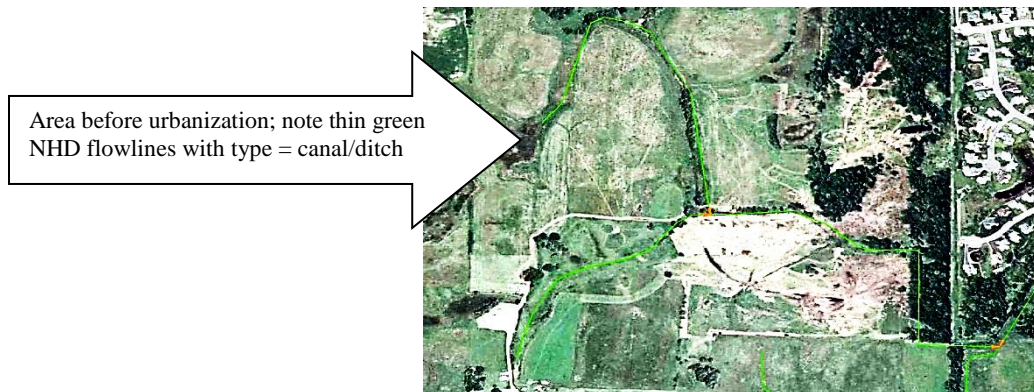
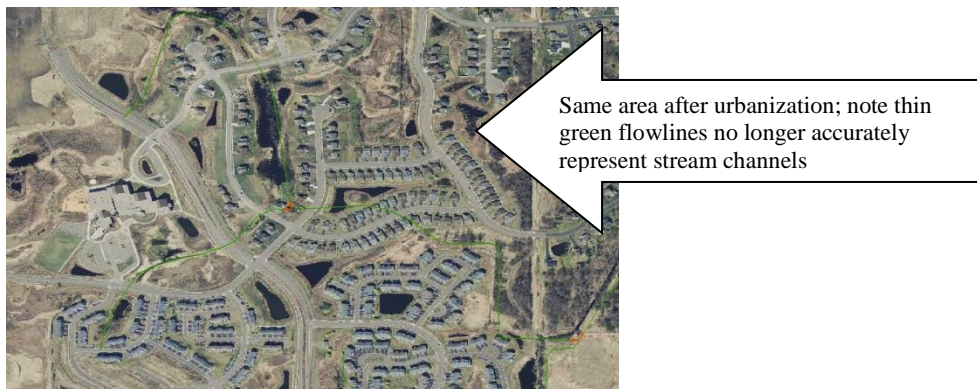
25. Surrounding terrain recently urbanized, mined or otherwise developed

The digitization of the NHD flowlines may have preceded development in an area and therefore not represent the current state of hydrography. In these cases, the flowlines and consequently the AW events built upon them are obsolete.

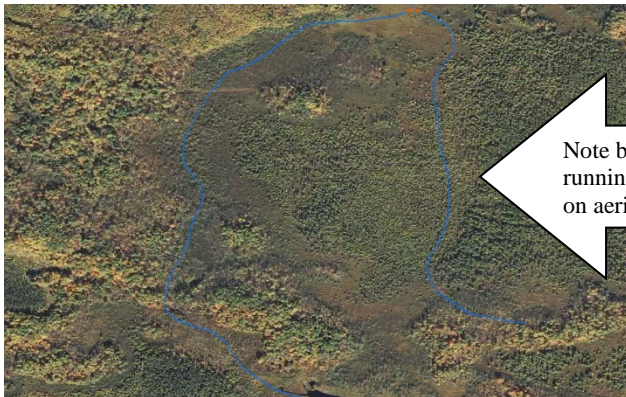
Water may flow through a wetland area in a very wide, indistinct path that is not visible on aerial imagery or LiDAR hillshade.

Note blue NHD flowline running through wetland area on aerial photo

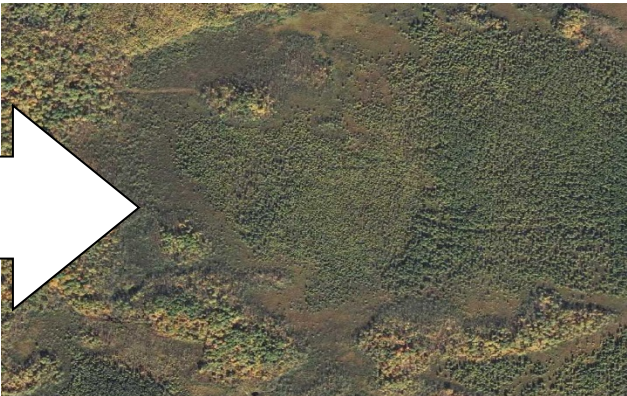
Same area with flowline removed; note no visible channel

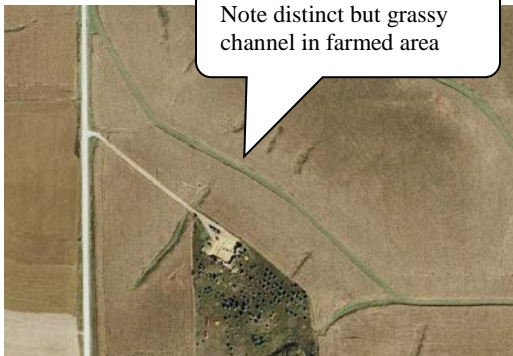
Sometimes channels that are clearly visible on aerial imagery and LiDAR hillshade are still not suitable for MPCA's purposes. These are wide, grassy channels frequently found in farm country.

Note distinct but grassy channel in farmed area

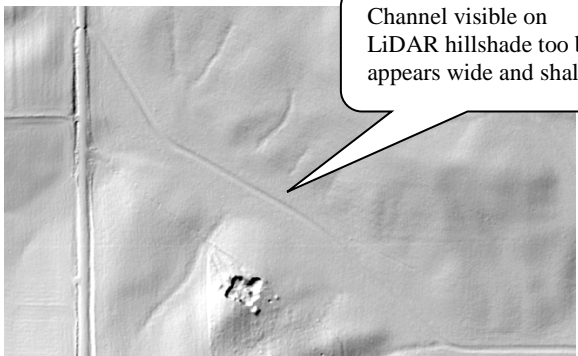
Channel visible on LiDAR hillshade too but appears wide and shallow

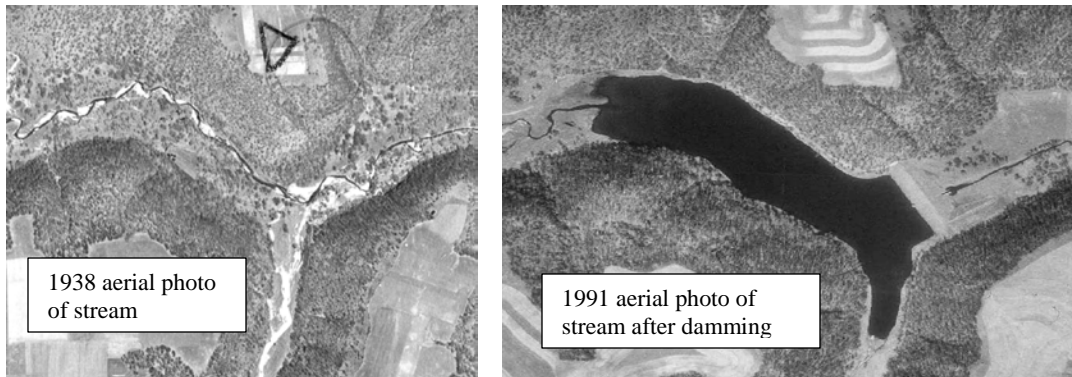
Because nature usually takes thousands of years to create a water body one that is formed over only a few years or decades may indicate that it is an impoundment.

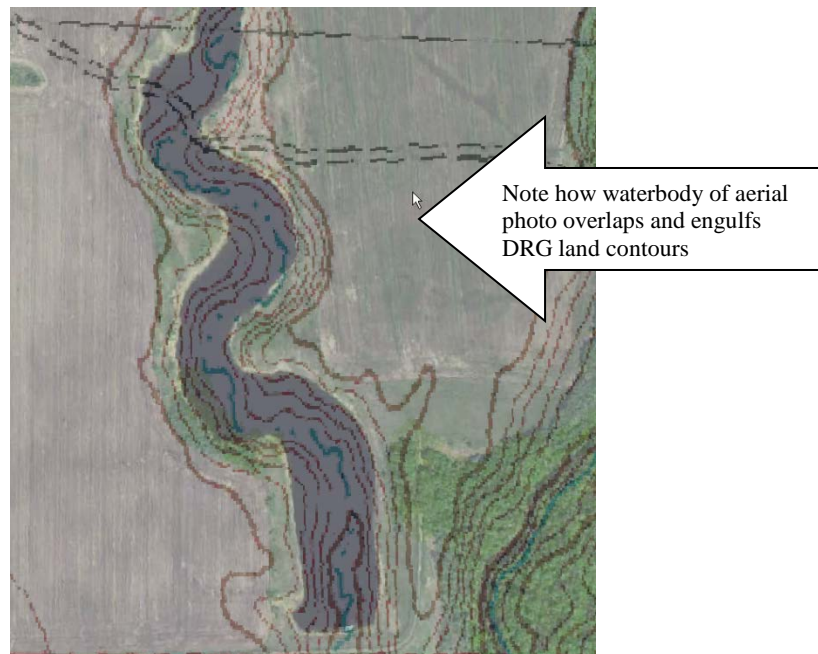
32. Waterbody overlies DRG land contours (but not due to registration errors)

If a waterbody succeeds and overlies DRG land contours then it may be impounded.

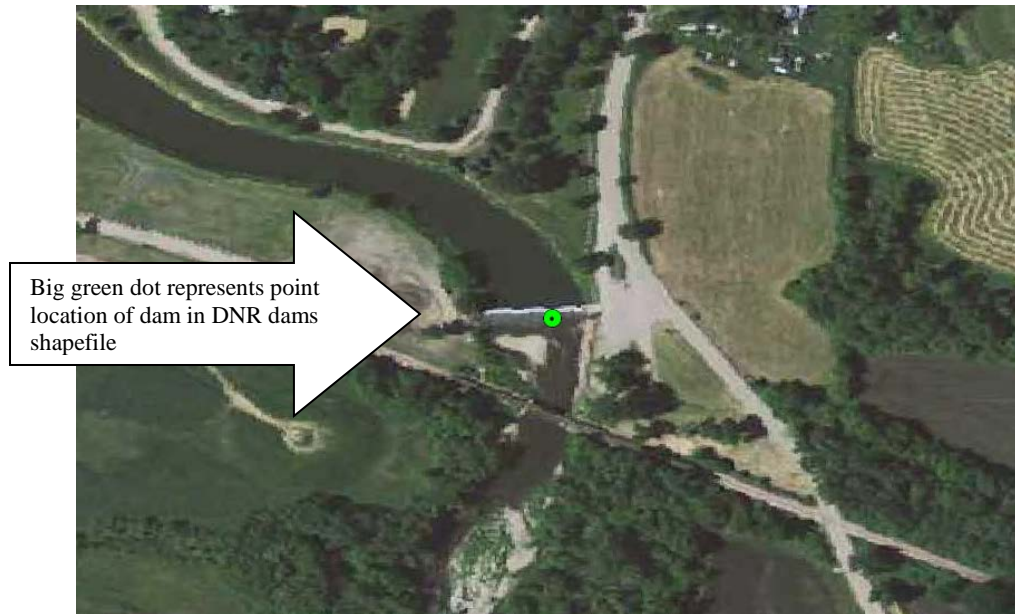
33. Waterbody has associated active dam in DNR dam shapefile

The DNR dam shapefile comes from the DNR Dam Safety group and is the most accurate vector point data of Minnesota dams available.

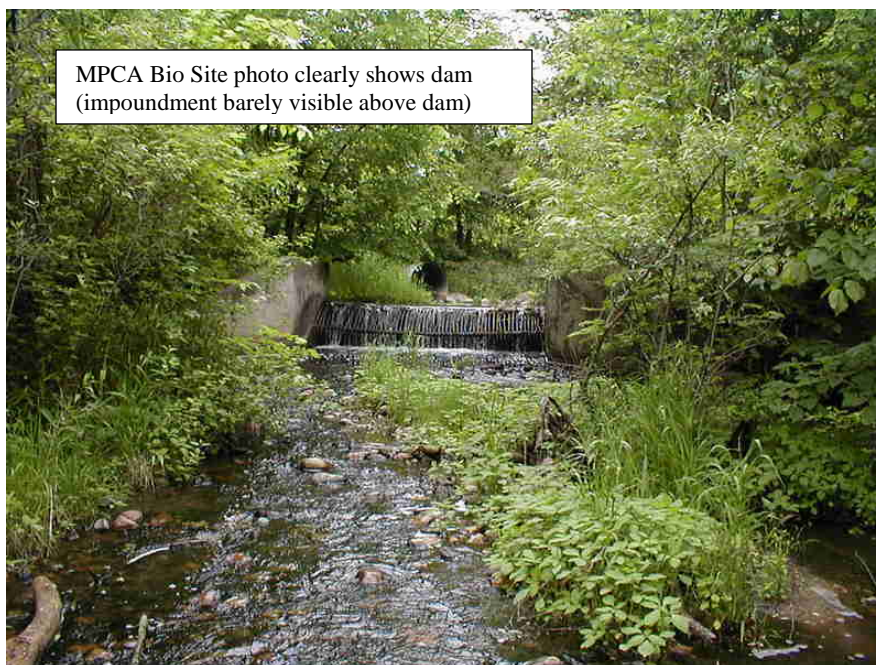
34. Associated MPCA Bio Site shows impoundment

Lateral photos taken at ground level at these sites may indicate the respective water body is an impoundment.

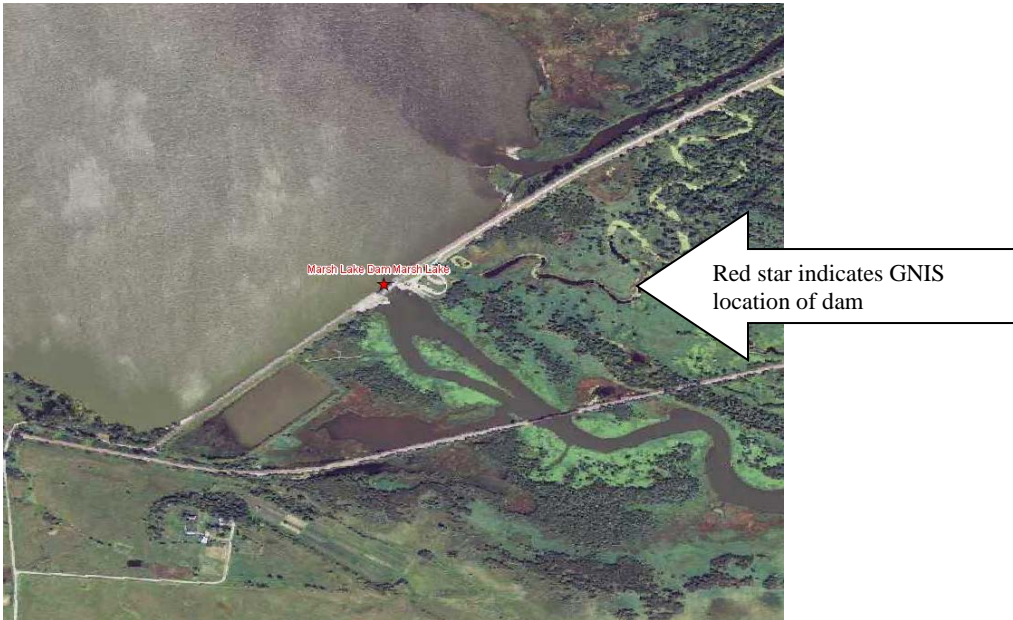
36. Associated GNIS feature's FEATURE_CL = dam or reservoir

The Geographic Names Information System (GNIS) data from USGS includes points for hydrographic features such as dams or reservoirs (impoundments).

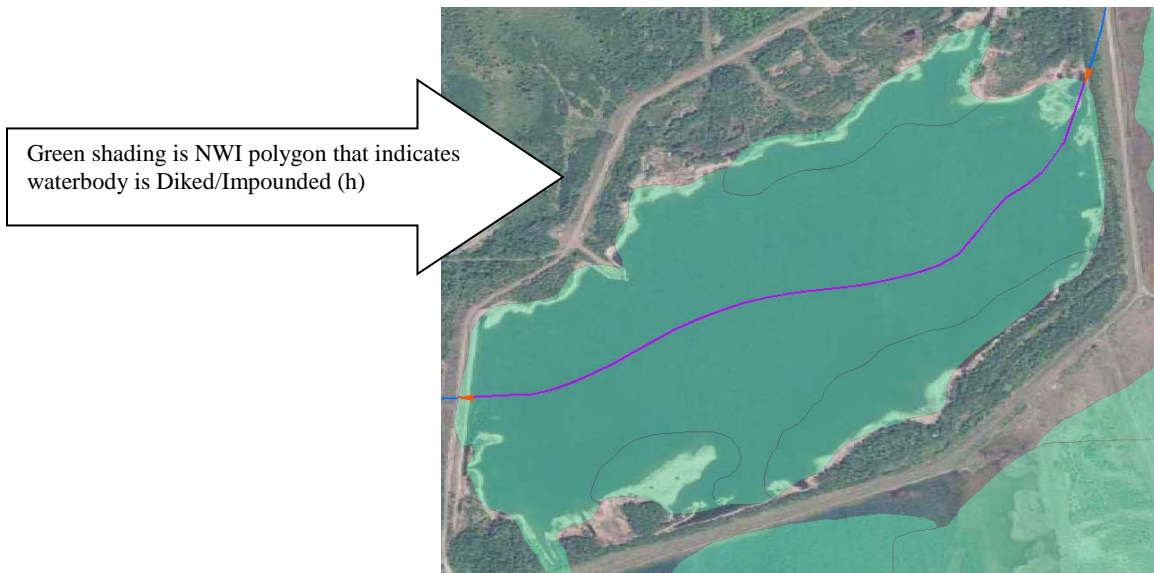
37. Associated NWI feature's SPEC_MOD is h (Diked/Impounded) or x (Excavated and NOT b (Beaver))

If the Special Modifier fields (SPEC_MOD) in the National Wetlands Inventory (NWI) dataset indicate that an area is Diked/Impounded (h) or Excavated (x) then the resulting water body may be impounded.

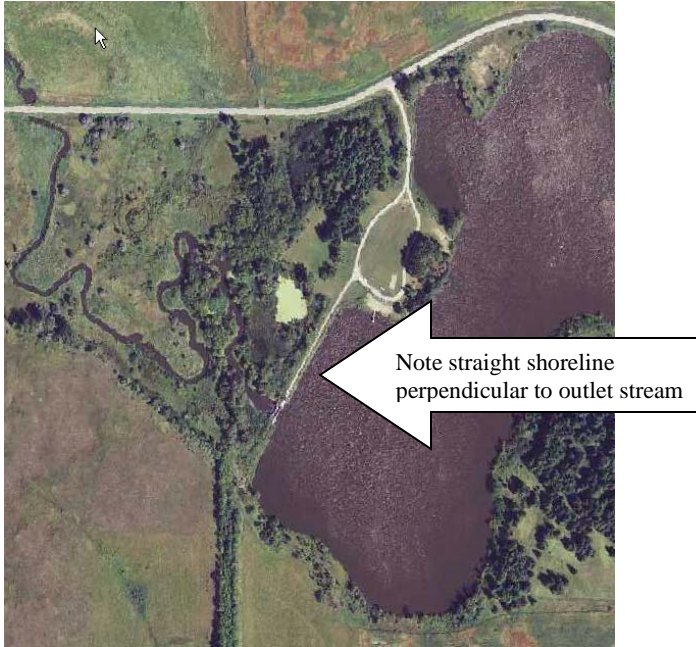
38. Waterbody has straight shoreline perpendicular to its outlet stream

A straight embankment of a water body at a right angle to its outlet stream is a clear indicator of a dam and impoundment.
