Altered Watercourse Determination Methodology

Final Revision (8)

**Minnesota Geospatial Information Office (MnGeo)
For
Minnesota Pollution Control Agency (MPCA)
June, 2013**

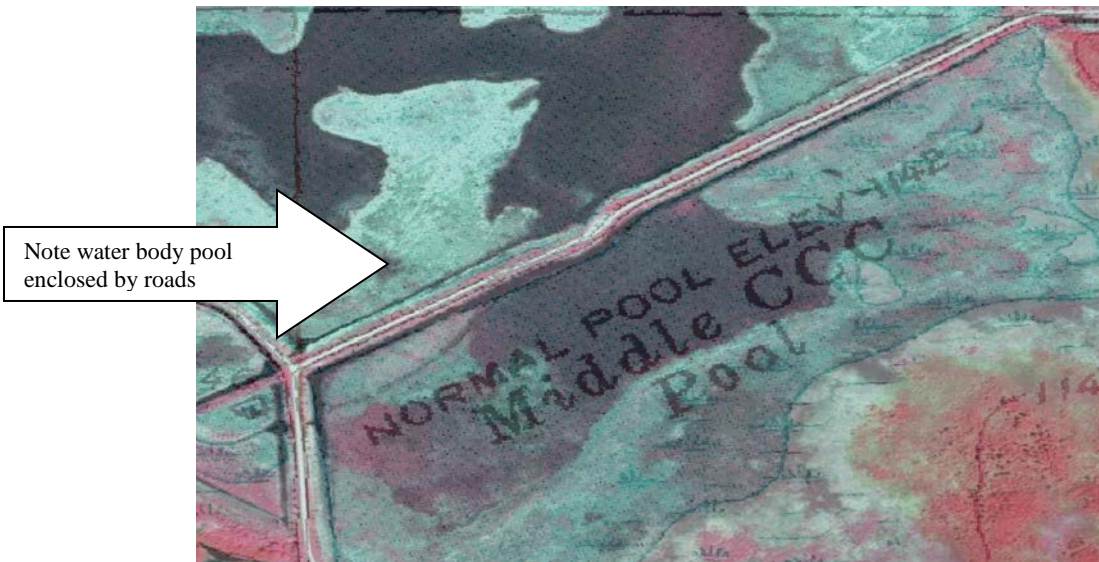
39. Associated DRG WB is labeled with words Pool, Normal Level, Reservoir, Spillway, or Tailings Pond

These terms often indicate a given water body is impounded.

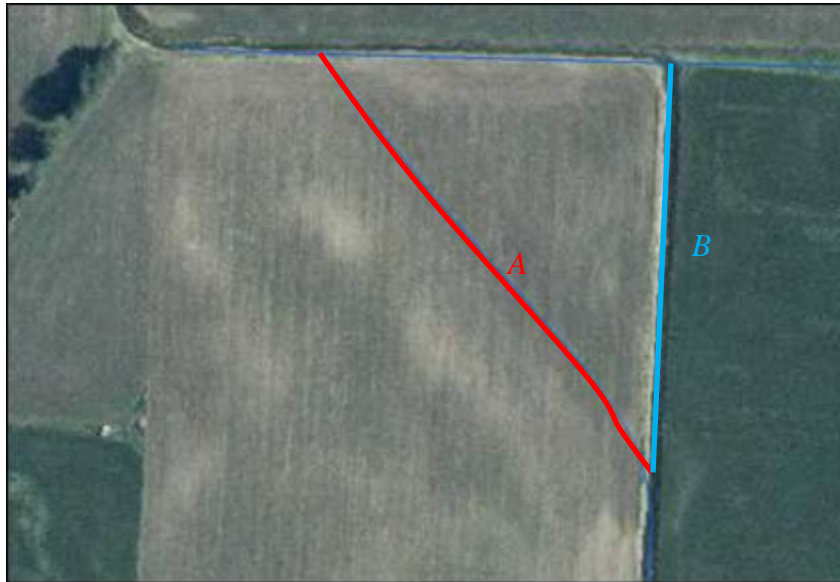
Example: Line *A* represents existing NHD flowline ditch which has been replaced by actual ditch (Line *B*)

- **Should Be** method – *A* is given *Altered* type (and NHD Update of *Change Geometry*) so that it can approximately represent the new correct ditch location at *B*.
- **Is** method – *A* is given *No definable channel* (and NHD Update of *Change Geometry*) type since a channel no longer exists there. *B* is not represented.

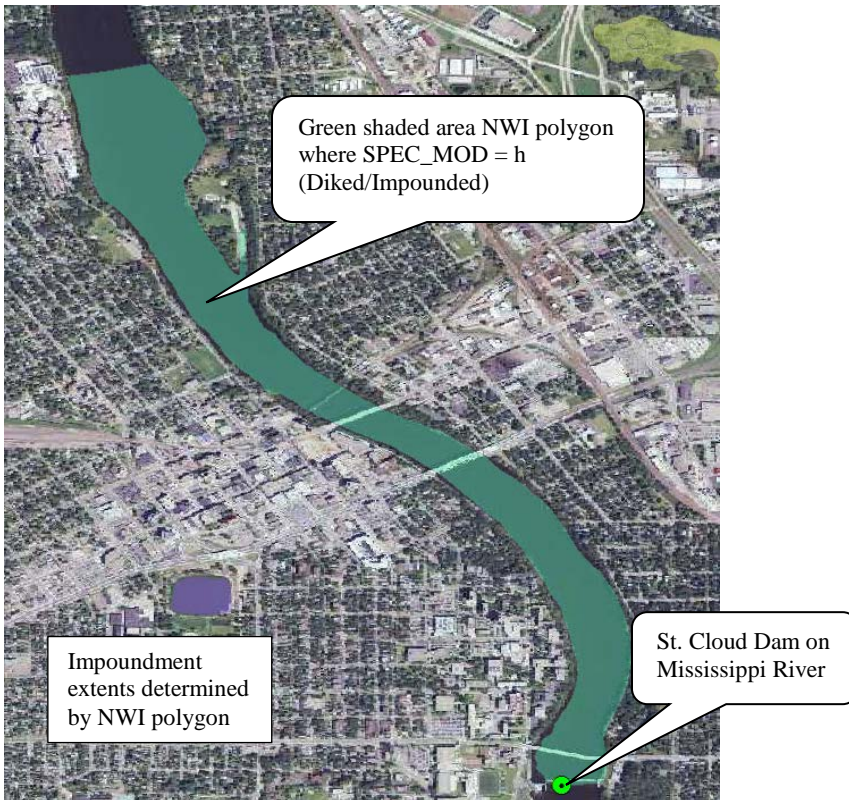
This is where some of the other reference data layers came in. It was decided that the NWI polygons where SPEC_MOD (Special Modifier field) = h (Diked/Impounded) or the DNR lakes polygons (e.g. PWI (Public Waters Inventory) or 24k lakes) would define the impoundment extents (see below). If neither of these existed behind a visible dam then it was presumed “offline” and the water behind it not impounded.

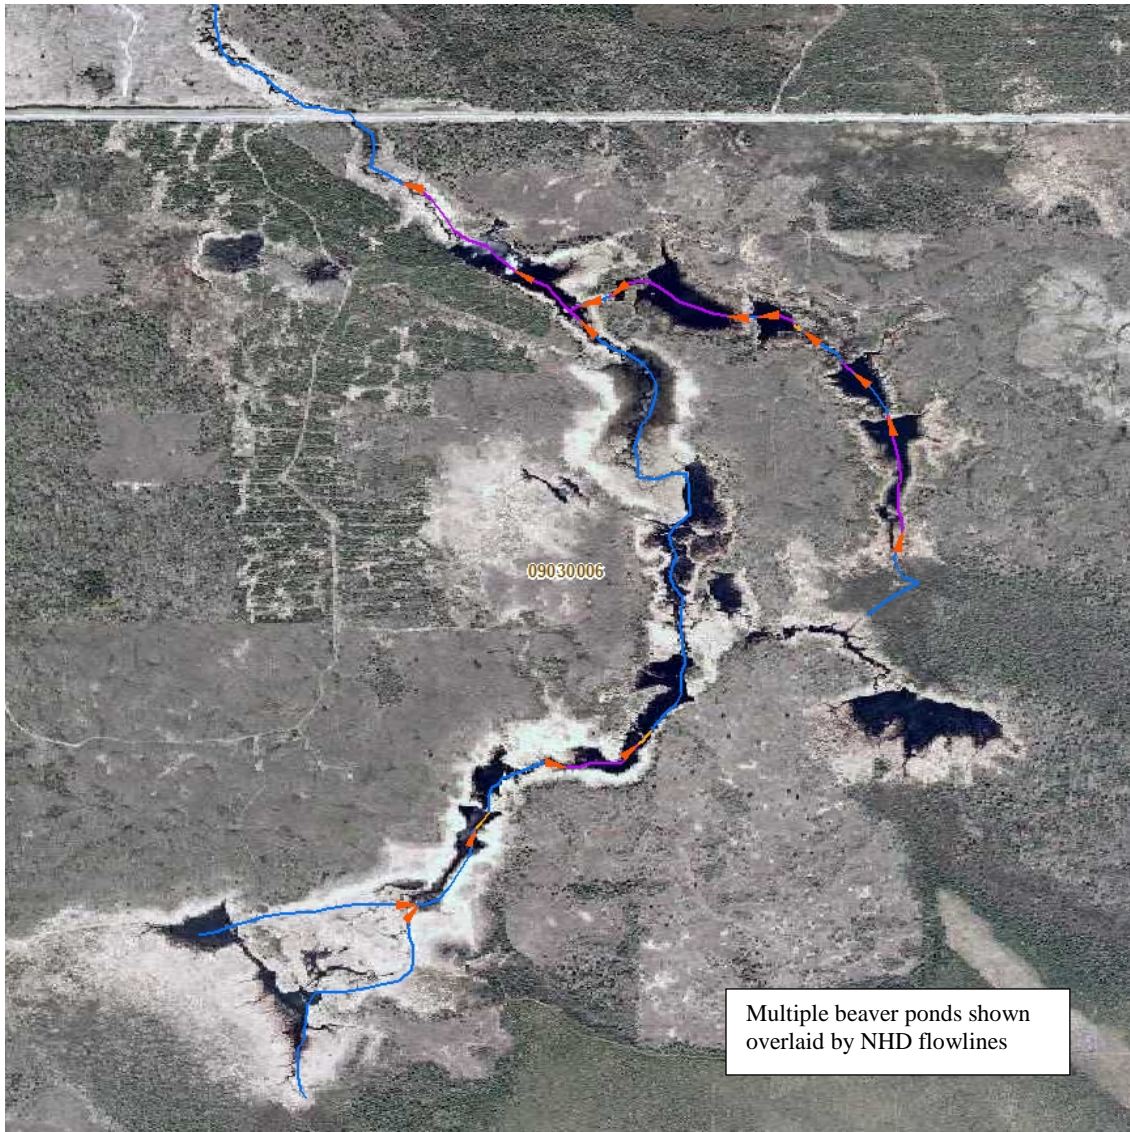
This method clarification seemed sufficient until some of the HUC-8s of the Arrowhead were encountered (e.g. Little Fork – 09030005). Many of the streams in these watersheds were so “beaver-infested” that it was difficult to tell whether individual beaver ponds persisted or not for the stipulated time period (see below). To prevent potentially unending designation times on these stream reaches (mostly headwaters) the current method was abandoned. In its place all such events were designated as either Natural or Altered as appropriate with the statement “Area dominated by beaver activity” entered into their Notes field.
